Manhole Inspection Summary

Manhole # S35KK_005MH

Insp Date: **3/12/07 10:37 AM**

Location Address: **127 TRENTON ST**

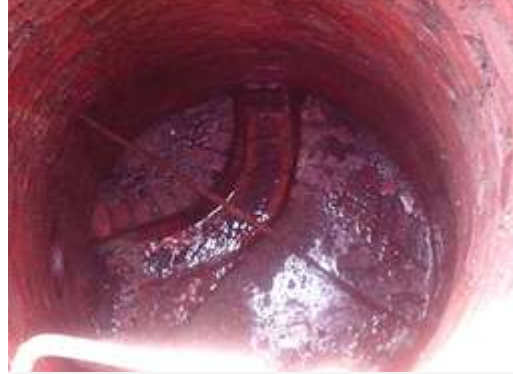
Top View

Bench ☒ Exists Material: **Brick** ☐ Parged ☒ **Debris** (not Condition related)

Surcharge ☒ **Evidence Of Surcharge** Depth: **1** (ft.) ☐ Active Surcharge Present

Evidence of surcharge - Bench debris.

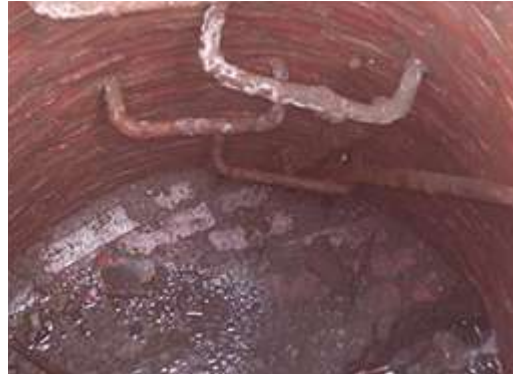
Defect

Steps Count: **5** Missing: **0** ☒ **Corroded**

Corroded steps.

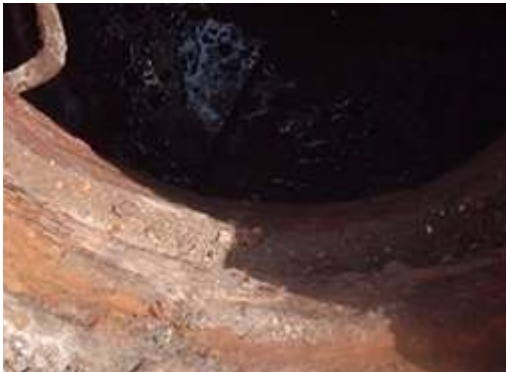
Defect

Frame Offset: **2** (in.) Condition: ☐ Sound ☐ Cracked ☒ **Leaks**

Condition: ☐ Sound ☐ Cracked ☐ Root Intrusion ☐ Loose Brick ☒ **Deteriorated**

Infiltration: ☐ None ☒ **Joint** ☐ Cracks ☐ Mortar ☐ Roots ☒ **Wall**

Frame leaks. Frame offset. Adjustment deterioration and infiltration.

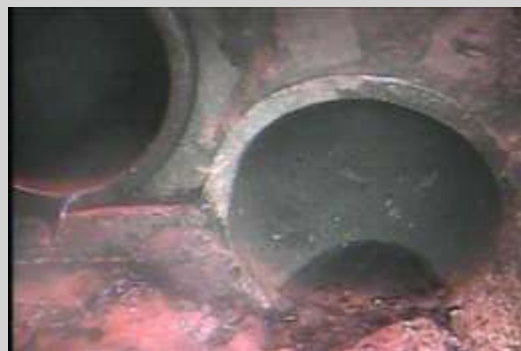
Drop In @ 9 O'Clock

Drop Condition: **Clogged**
